The Adverse Effects of Water Spots and Air-Borne Deposits on Glass in Buildings; Justification for Frequent and Systematic Cleaning

This bulletin has been commissioned by the Glass Committee of the International Window Cleaning Association and authored by Paul F. Düffer Ph.D., Technical Program Adjunct to the Glass Committee; Paul D. West, Chairman.

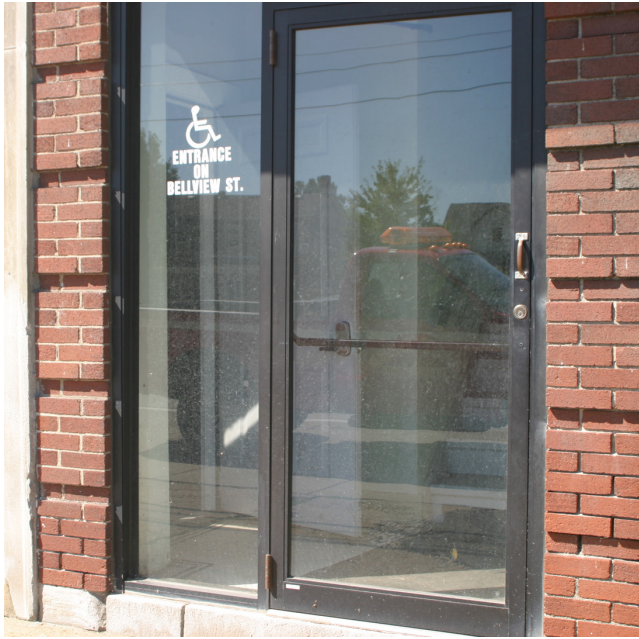
Glass that appears dirty and soiled is often affected by an accumulation of particulates that are characteristic of the everyday environment and not necessarily composed of exotic airborne pollutants. For example, the soiled door shown in Figure 1 exhibits an accumulation of ordinary dust and grime that originated from a relatively commonplace environment.

Figure 1: Entrance door on a municipal building located within 30 feet of a busy roadway.

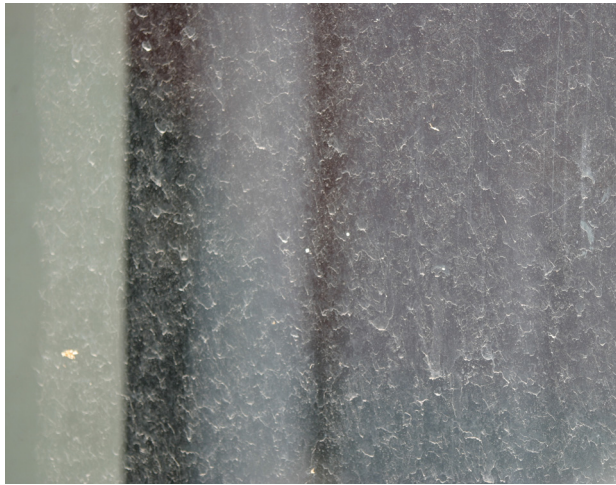
Figure 2: Close-up view of municipal building entry door reveals a significant accumulation of dirt and

A close-up view of the door in question is displayed in Figure 2 and provides a more detailed view of what appears to be a significant amount of dirt and soiling. While this particular view of dirty glass does not appear to be inherently unusual, a different perspective is unveiled by examining this same grit and grime with the aid of a scanning electron microscope. Such a view is presented by the photograph presented in Figure 3.

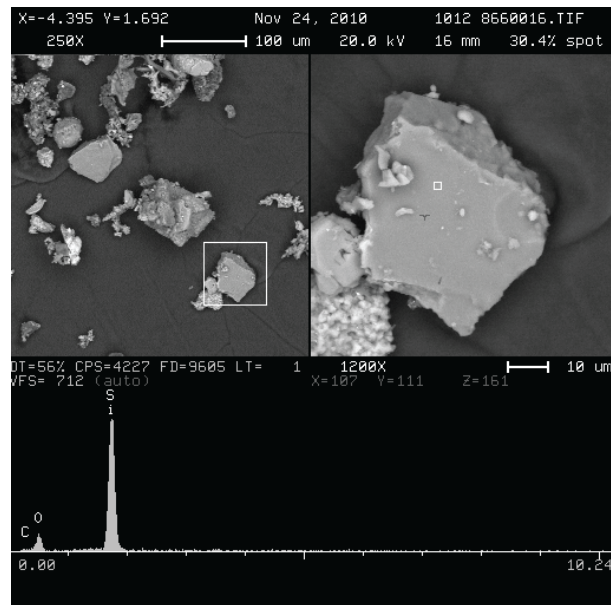
The left hand frame of Figure 3 was taken at a magnification of 250X and reveals the dirty glass of interest to be littered by a variety of irregularly shaped particulates. Many of these measure less than 100 microns in either length or diameter (0.1 millimeters or 4/1000 of an inch). However, more important than size is the chemical composition of the particulates. For example, the right hand frame in Figure 3 focuses on a sharp-edged entity magnified 1200 times for which the compositional analysis reveals the presence of silicon oxide (SiO_2). In other words, a particle that can be more commonly identified as a grain of sand.

Although small in size, the presence of sand particles is not a trivial matter since SiO_2 is harder than glass and thus has the potential to initiate surface scratches. However, surface scratching is not necessarily a forgone conclusion if particulate removal is undertaken by a skilled window cleaning and maintenance specialist.

Figure 3: Microscopic view of particulates sampled from municipal building entry door which include entities that are composed of silica (sand). Left hand frame shows particles magnified 250 times (250X) while frame on right is shown at 1200X.

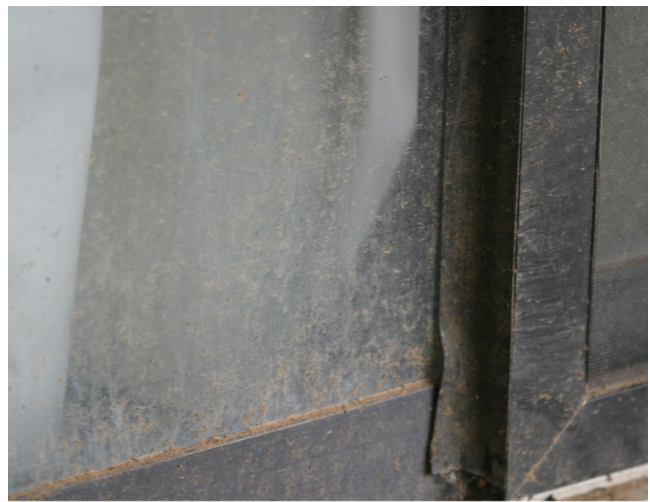
cited in the first example are not necessarily unique. In this instance, attention is focused on the vacation home pictured in Figure 4 which is located in the mountains of northwest Virginia. Here again, as was the case with the municipal building door, some significantly soiled glass can be identified as illustrated in Figure 5.

Fig. 5: Close-up view of dirt and soil on window at

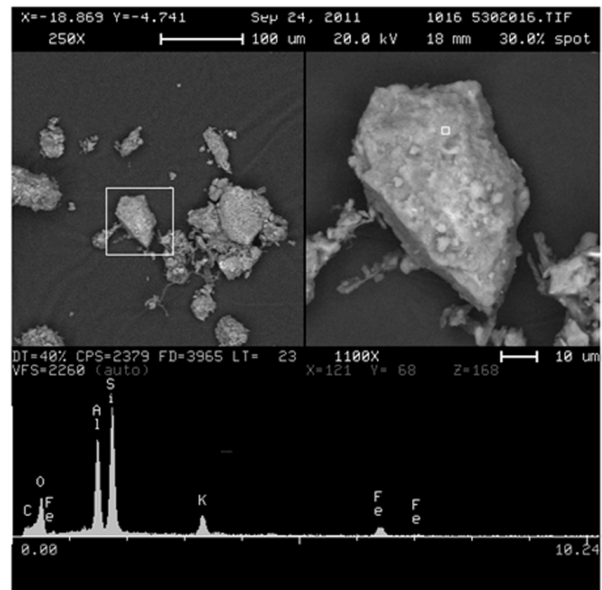
When examined with the aid of a scanning electron microscope, the dust and dirt in this example reveal the interesting physical features that are shown in Figure 6. As in example 1, the observed window dirt is an assembly of numerous irregularly shaped particles that are on the order of 100 microns or less in size.

Compositional analysis in this example also reveals the presence of silicon oxide (sand grains) as well as aluminosilicate material which are both harder than commercial flat glass. As a consequence, each of these materials has the potential for initiating surface scratching when removed from a glass surface without the appropriate precautions that are employed by window cleaning-professionals.

Figure 6: Particulates from Virginia window magnified 1100 times via a scanning electron microscope

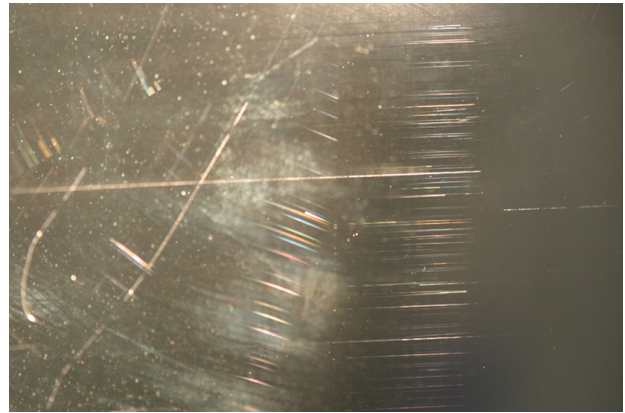
Figure 7 presents an example of a window unit that exhibits a variety of small surface scratches. The significant population of these suggests that a large number of minute, relatively hard particulates were moved in a circular motion over the glass surface in question. However, the key point here is not necessarily the damage done to this particular unit, but, rather, consideration of the fact that had a skilled professional been engaged in this project, there would be little or no discussion of post-cleaning damage. A second example for which numerous scratches appear on glass is presented in Figure 8. Once again, the observed scratches are indicative of an absence of sufficient care and diligence having been exercised during cleaning.

Figure 7. Close up view of a previously soiled window surface after cleaning. The observed scratches suggest that washing was undertaken by someone lacking the skills of an experienced professional window cleaner.

The incidents of glass scratching illustrated in these examples place renewed emphasis on the inherent wisdom in engaging the regular services of a professional window cleaning contractor, such as a member of the International Window Cleaning Association (IWCA), as part of a damage mitigation and preventive maintenance strategy.

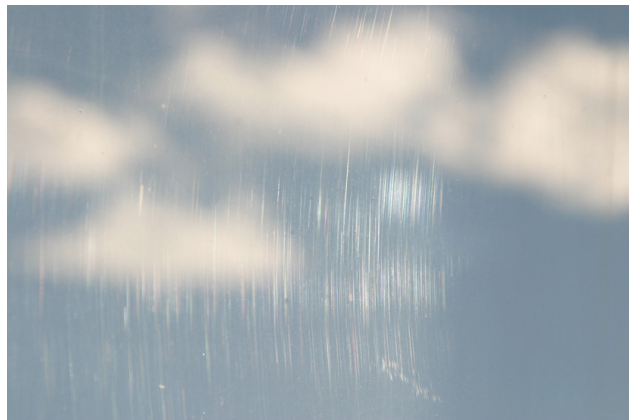
Figure 8: Another example of a window glass surface where the observed scratches are indicative of cleaning in the absence of an experienced professional.

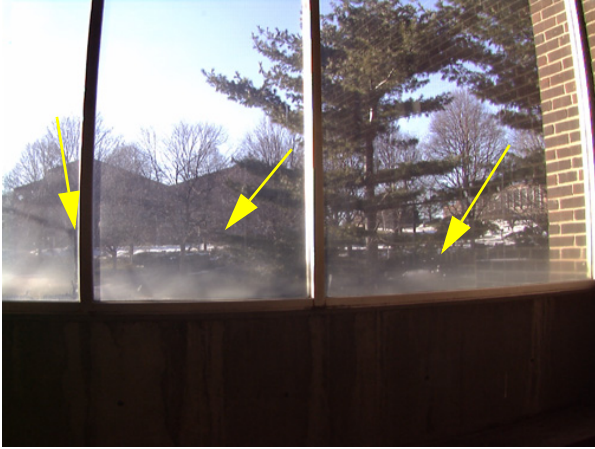
shown in Figure 9 provides a graphic illustration of the typical outcome associated with such attempts. The close up view of concrete runoff deposits presented in Figure 10 reveals the characteristic pattern associated with this problem.

Figure 9: Visible gray haze due to deposits on glass from concrete runoff. Implementation of conventional cleaning procedures failed to remove deposits.

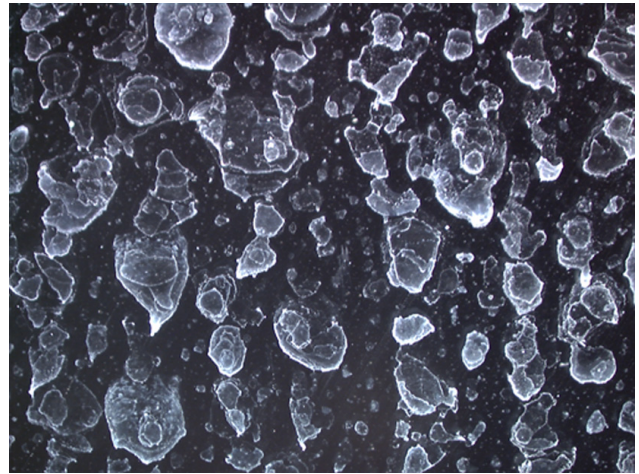
For many years, conventional wisdom has maintained that runoff from concrete surfaces damages glass due to an alkaline etching or erosion of the surface. However, more recent scientific study has shown concrete runoff to be characterized by deposits of amorphous materials that reside on the glass surface.³ Whenever rainwater makes contact with a concrete surface, small amounts of silicate materials are dissolved with concentrations of 4 to 8 parts per million being quite common. Upon coming to rest on glass, these dissolved silicate materials gradually become more and more concentrated as the runoff droplets evaporate. Finally, a point is reached where formation of water insoluble polymers begins. This same reaction also results in chemical bonding to the glass substrate. In addition, experiments have shown this process to be significantly more rapid than either glass surface corrosion or true alkaline etching.⁴ In fact, prior work has shown the reaction to reach completion at the point when the water carrier evaporates to dryness. This could take hours or as little as a few moments to occur depending upon environmental conditions.

Figure 10: Close up view of typical concrete runoff deposits on glass. These deposits begin to react with glass upon evaporation of the runoff droplets resting on the glass

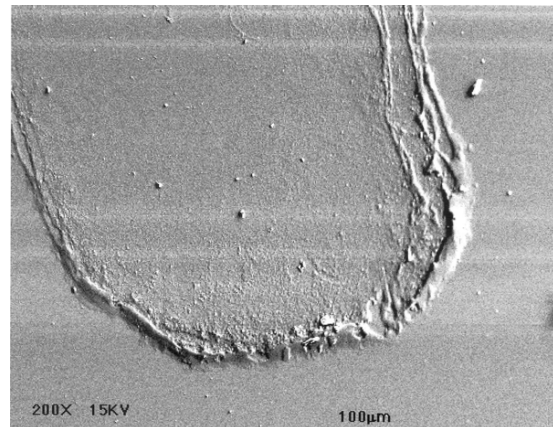
Figure 11 offers a view of concrete runoff obtained with the aid of a scanning electron microscope. The magnified image clearly shows the deposit to be residing on top of the glass. There is no evidence of erosion or pitting that would be observable had chemical etching occurred. In addition, previous studies (See reference 1.) have shown these deposits to be glass-like with respect to both structural and solubility attributes.

Figure 11: Magnified view of concrete runoff deposit on glass taken with scanning electron microscope; 200X.

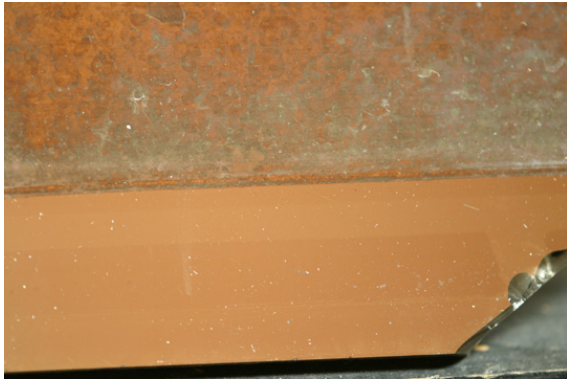
concrete runoff accumulating on glass with a solar reflective coating on the No. 1 surface. A magnified view is presented in Figure 13. The glass in question had been removed from an existing glazing installation due to suspicions that the coating was defective as a consequence of compromised durability. These reservations arose when it was observed that conventional cleaning failed to restore the glass to its pristine condition. However, subsequent investigation identified the deposits to be silicate residue from concrete runoff

Figure 12. Concrete runoff deposits on coated glass unit removed from an existing glazing installation. Note the line of demarcation at point where glass was protected by framing.

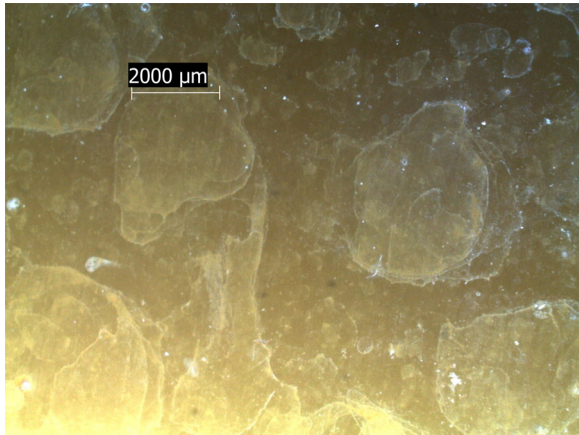
Figure 13: Magnified view of silicate residue from concrete runoff on a coated glass surface; shown at 10X.

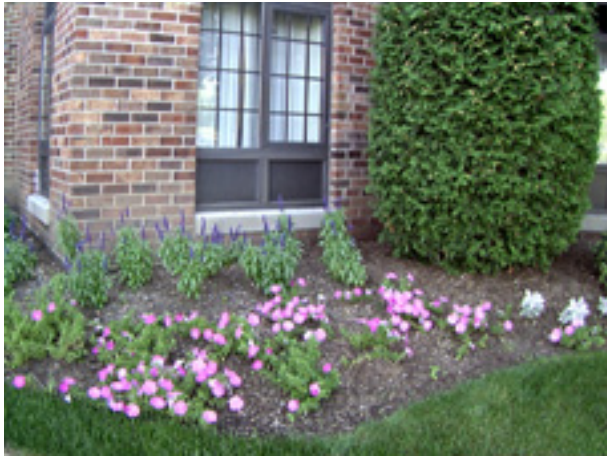
Fig. 14 Hotel window with adjoining decorative garden and hidden pop-up irrigation system.

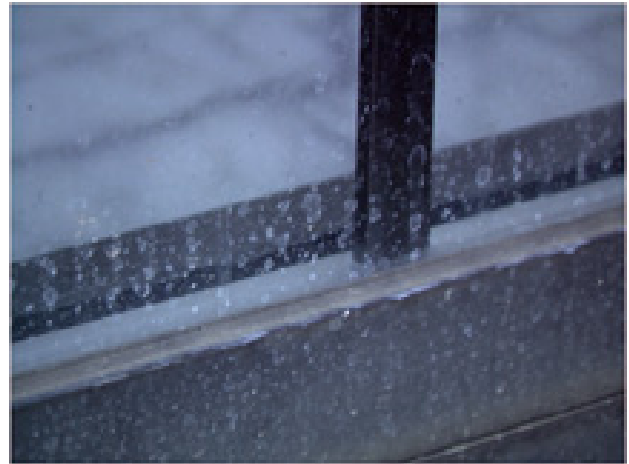
In a manner similar to the process involved in formation of concrete runoff deposits, whenever hard water droplets containing dissolved silicates evaporate, these materials become increasingly more concentrated as the liquid volume decreases.^{5,6} Eventually, the silicates begin to bond with one another as well as the glass surface producing what is akin to a “glass-on-glass” deposit. Just like concrete runoff, these glass-like entities fail to respond to common household cleaning agents. Vinegar and other weakly acidic solutions will not dissolve the silicate deposits. A good example of this is shown in Figure 15 which presents a close up view of the window shown in Figure 14. In this instance, repeated contact with hard water droplets from an adjacent lawn sprinkler has created a significant build up of silicate material.

Figure 15 Hard water spots containing silicate materials after normal attempts at cleaning.

The general condition of the window under consideration here suggests that a regularly scheduled program of cleaning and maintenance had not been implemented by the time the photograph was taken. Of course, the preferred course of action is to prevent such conditions from developing in the first place by consistently employing the services of a window cleaning professional.

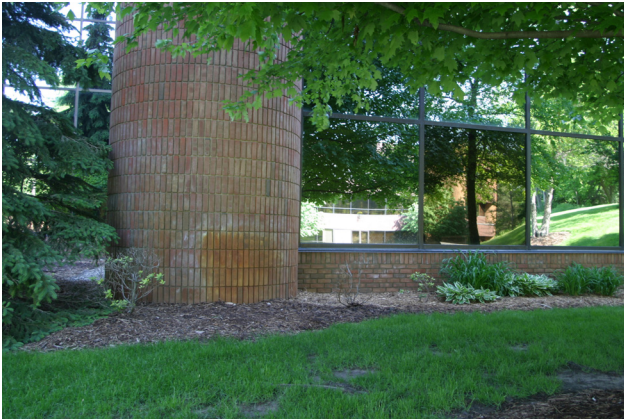
restricted to uncoated surfaces. Figure 16 presents a view of a suburban office building with adjacent lawn and garden features similar to those observed in Figure 14. However in this instance the glazing system incorporates a reflective coating on the outer or No. 1 surface. Nevertheless, silicate deposits that emanate from hard water spots are equally resistant to removal as illustrated in the close up view shown in Figure 17.

Figure 16 Suburban office building with glass coated on #1 surface.

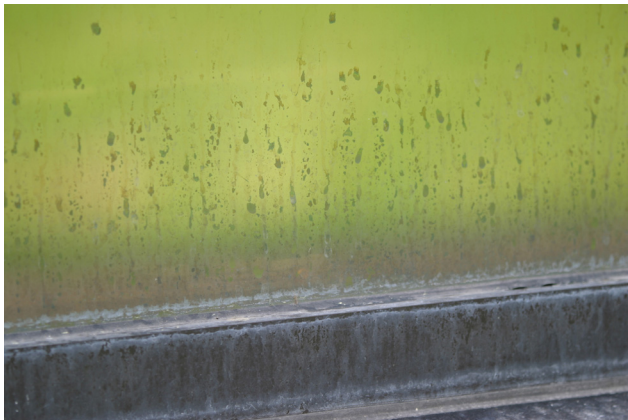
Figure 17: Close up view of silicate deposits on a coated glass surface arising from repeated contact with hard water droplets.

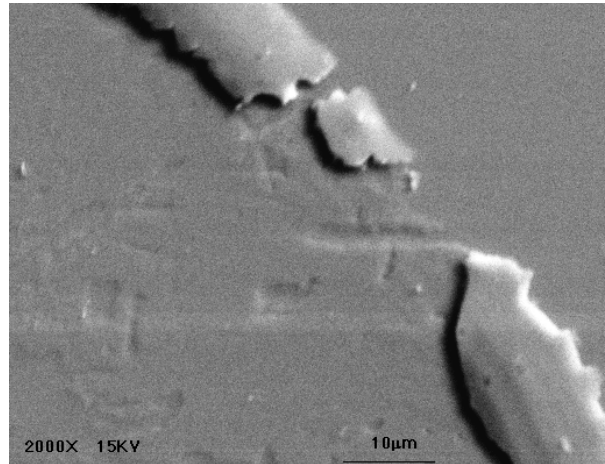
With the aid of an electron microscope, one is able to discern that silicate residue from hard water is similar in physical appearance to deposits from concrete runoff. This characteristic is displayed in Figure 18 which presents a silicate deposit magnified 2000 times. The glass-like silicate residue lies

on the substrate surface and extends a small distance above the point of contact. There is no evidence that chemical erosion or etching has occurred.

Figure 18: Glass-like silicate deposit on glass magnified 2000 times with an electron microscope.

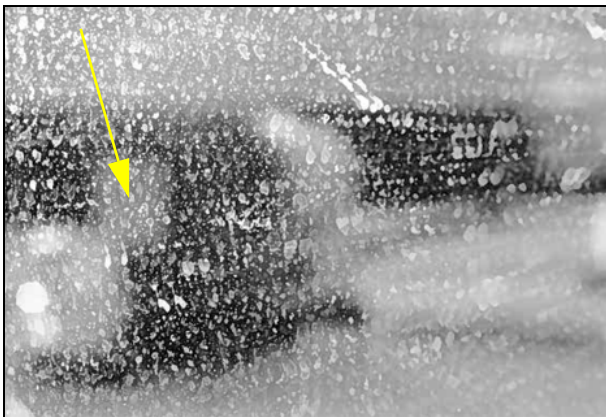
An example of a successful restoration project is shown in Figures 19a and 19b. Figure 19a presents the “before” view one would have seen when attempting to look through this window that has been heavily soiled by silicate-bearing water spots. Having resisted normal cleaning procedures, this window was later subjected to a polish-in-place restoration process. The outcome of this effort is presented in Figure 19b where one can easily identify a mezzanine roof exhaust unit that was previously obscured from view.

Figure 19a. View looking through a window that is severely soiled by stubborn water spotting. Exhaust unit on mezzanine roof is obscured by surface deposits

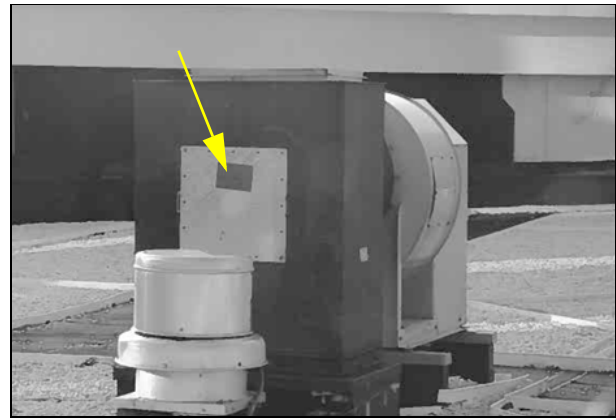
Figure 19b. View through the same window after successful implementation of a glass surface restoration procedure. Exhaust unit is now clearly visible.
