The Adverse Effects of Water Spots and Air-Borne Deposits on Glass in Buildings; Justification for Frequent and Systematic Cleaning

This bulletin has been commissioned by the Glass Committee of the International Window Cleaning Association and authored by Paul F. Düffer Ph.D., Technical Program Adjunct to the Glass Committee; Paul D. West, Chairman.

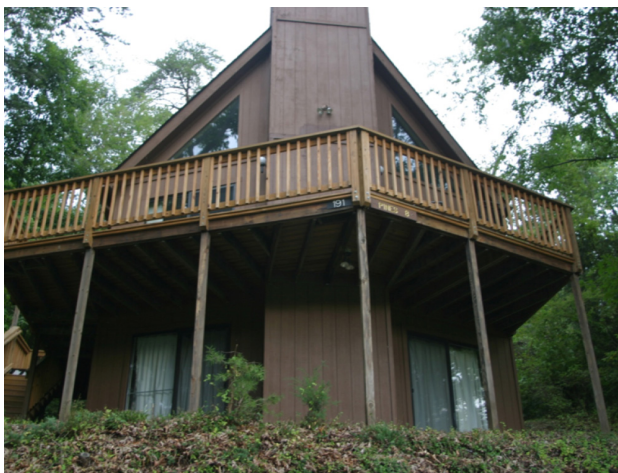
Fig. 4: Vacation home in the mountains of Virginia.

cited in the first example are not necessarily unique. In this instance, attention is focused on the vacation home pictured in Figure 4 which is located in the mountains of northwest Virginia. Here again, as was the case with the municipal building door, some significantly soiled glass can be identified as illustrated in Figure 5.
